TECHNICAL REPORT REMR-OM-14

REMR MANAGEMENT SYSTEMS—NAVIGATION STRUCTURES

**CONDITION RATING PROCEDURES  
FOR TAITER AND BUTTERFLY VALVES**

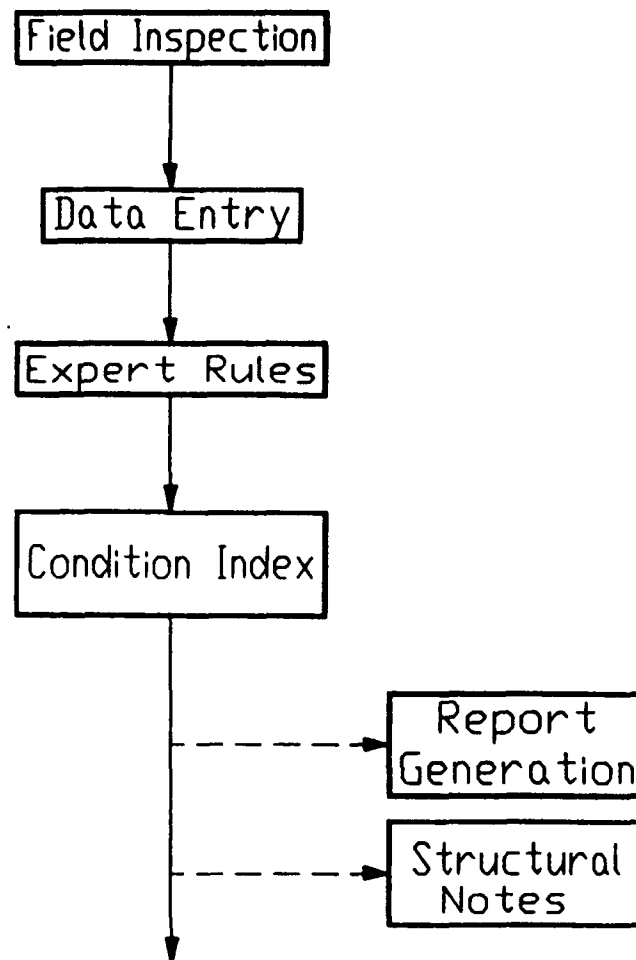
Figure 1. Inspection and rating procedure

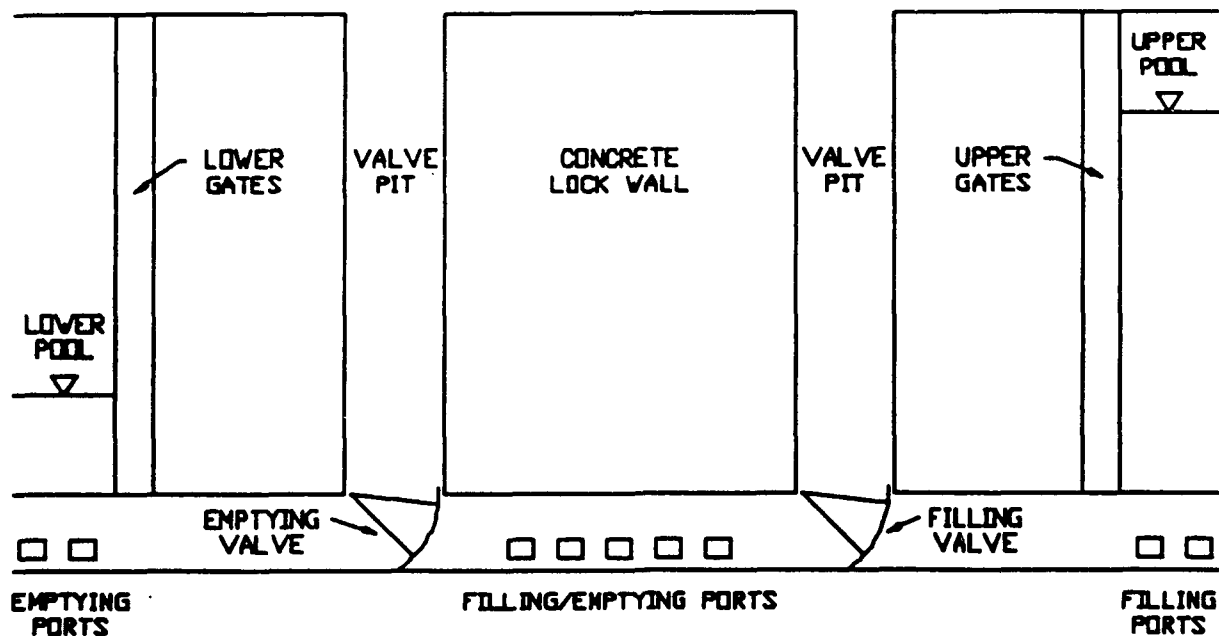
Figure 2. Lock chamber schematic

12. Valves are used inside the culverts of the filling and emptying systems of lock structures (Figure 2). Two valves are necessary in each longitudinal culvert. A filling valve is located between the upper pool intake and the chamber intake ports. An emptying valve is located between the chamber outlet ports and the lower pool discharge.

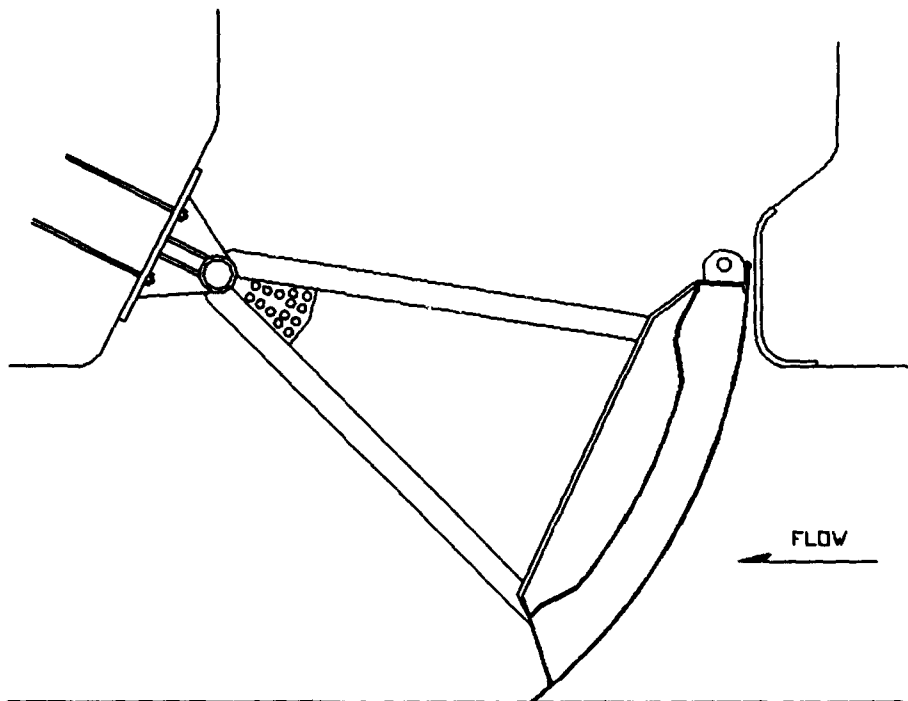
Figure 3. Conventional tainter valve

14. Initially, tainter valves were designed similar to the spillway tainter gates used on dam structures. These valves were oriented with the trunnions downstream of the skin plate causing the convex surface of the skin plate to face the flow and seal along the upstream end of the valve pit (Figure 3). After studies showed that this design could cause air to be pulled into the culvert, a reverse tainter valve design was introduced (US Army Corps of Engineers, 1975). This orientation placed the trunnions upstream of the skin plate with the convex surface of the skin plate facing downstream and sealing against the downstream end of the valve pit (Figure 4). Valves of this general design have been used on most locks constructed by the Corps of Engineers in recent years.

15. A tainter valve is generally anchored to the concrete with an anchor plate and a trunnion bearing bolted to an embedded frame. Because the trunnion assembly of a tainter valve is downstream, the strut arms are in compression (Figure 3). In the case of reverse tainter valves, there are two distinct types of anchorage design. The first and more common design uses a

**Trunnion Assembly:** The trunnion assembly consists of a set of components that make up the hinge system of the valve. It transfers load from the strut arms into the embedded anchorage system in the culvert walls. Specific arrangement of components varies, depending on the configuration of the anchorage design (Figures 3, 4, and 5).

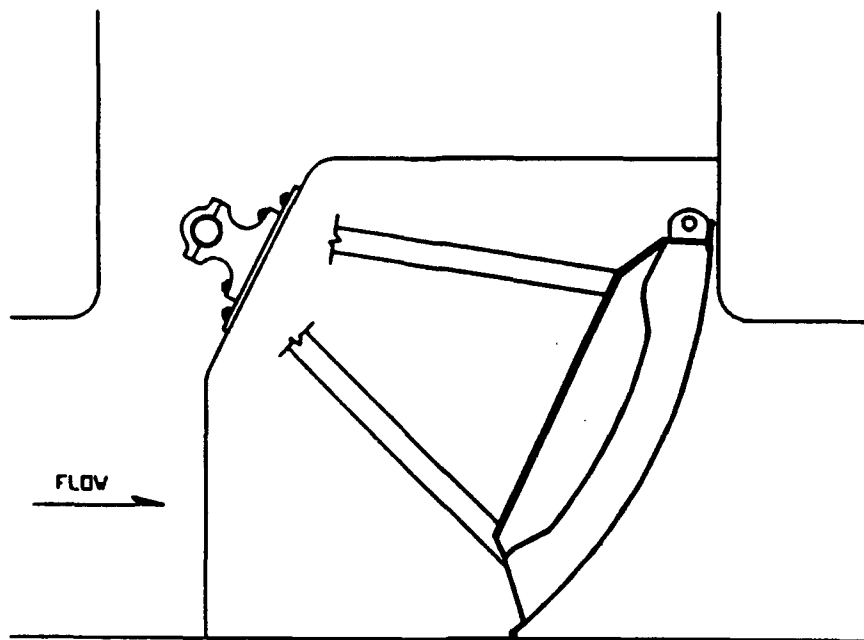
Figure 4. Reverse tainter valve

bearing plate arrangement anchored on a concrete shelf on each side of the culvert (Figure 4). The strut arms are in tension. Anchor bolts are connected to an embedded framework inside the culvert walls. In this design, the anchorage assembly is in compression. The second design, uses U-bolts to anchor the valve to the concrete (Figure 5). The U-bolts are connected to an embedded trunnion girder. This type of design puts the anchorage assembly in tension.

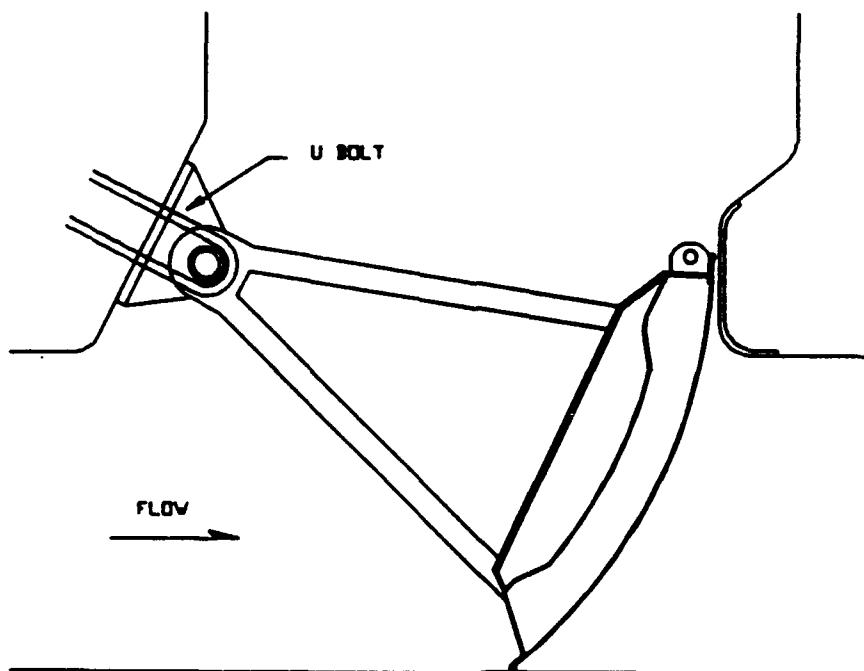
Figure 5. Reverse tainter valve U-bolt arrangement

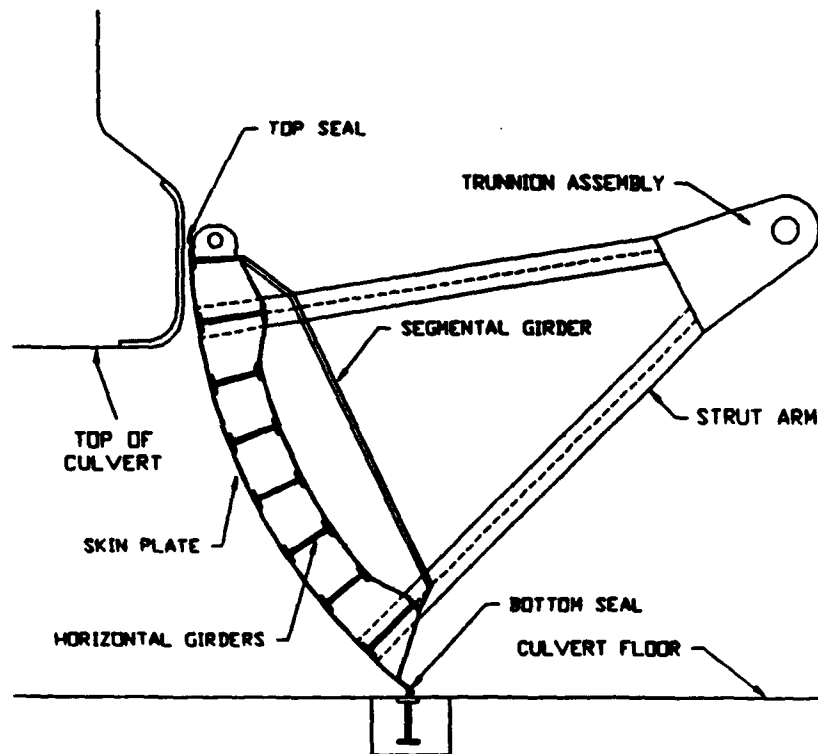
Figure 6. Tainter valve components

**Strut Arms:** Strut arms are the steel girders that transfer load from the segmental girders to the trunnion assembly (Figure 6).

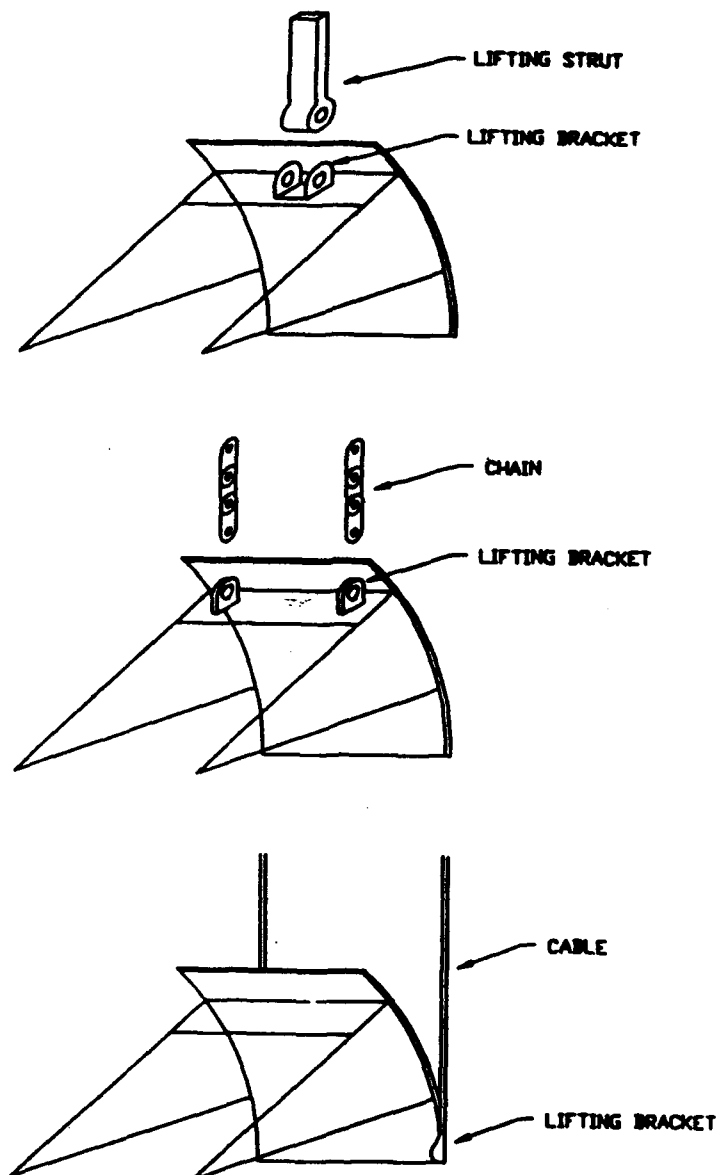
Figure 7. Tainter valve lifting methods

**Lifting Strut:** The lifting strut connects the operating machinery with the valve structure (Figures 7 and 8). It extends down into the valve pit and moves the valve between its open and closed positions.

**Lifting Chain or Cable:** Sometimes the valve is lifted by a chain or cable rather than a strut (Figure 7). Its function is the same as a lifting strut.

**Lifting Bracket:** The lifting bracket is usually located on the top side of the valve and connects the lifting strut to the valve structure (Figure 7). In the case of a cable-lifted valve, the cables connect to the bottom of the valve arch (Figure 7).

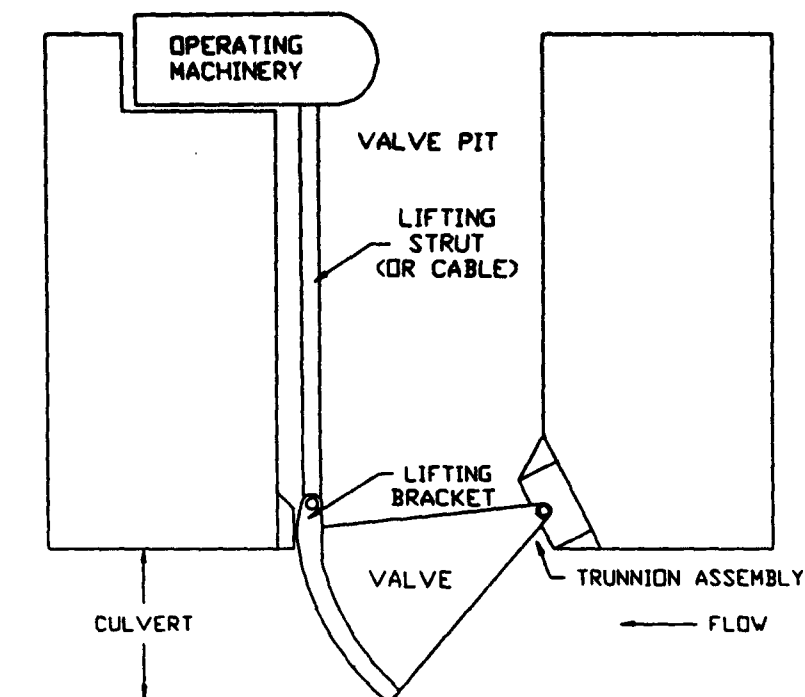
Figure 8. Tainter valve schematic

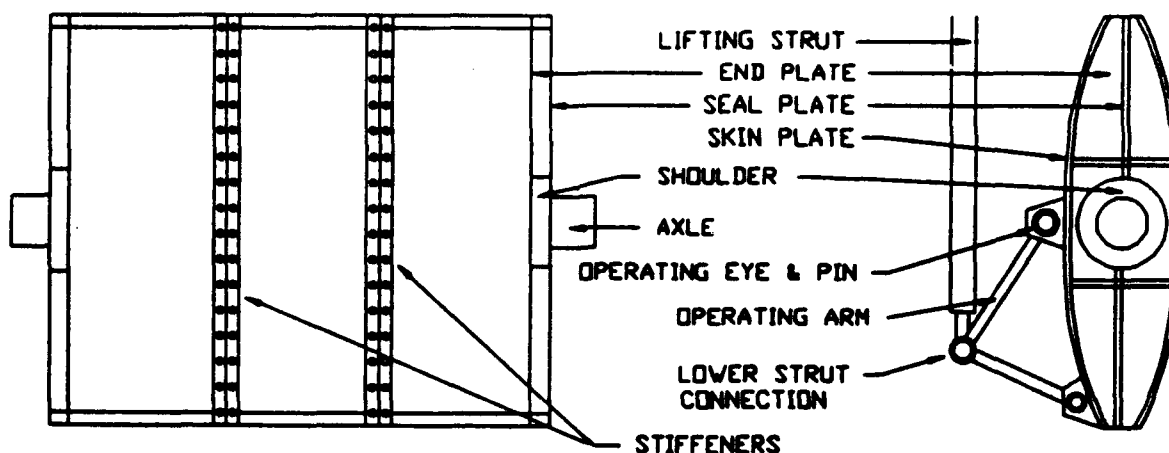
Figure 9. Butterfly valve components

**End Plate:** End plates are welded onto the sides of the valve to enclose the ends of the valve and transfer load to the axle (Figure 9).

**Seal Plate:** Seal plates are attached to the perimeter of the valve to provide a sealing surface (Figure 9). Either rubber seal strips are attached, or the steel-to-steel contact will provide an adequate seal.

**Shoulder:** The shoulder is a spacer surrounding the axle that absorbs the lateral thrust and centers the valve in the culvert (Figure 9).

**Lifting Strut:** The lifting strut connects the operating machinery with the valve structure (Figure 9). It extends down into the valve pit and moves the valve between its open and closed positions.

**Lower Strut Connection:** This is the bottom connection point of the strut to the operating arms (Figure 9).

**Operating Arms:** Operating arms are cast steel members that connect the lifting strut to the body of the valve (Figure 9). There are two sets of arms on each butterfly valve. As the lifting strut is raised or lowered, one set is in tension and the other set in compression, causing the valve to rotate.

**Operating Eyes:** Cast steel operating eyes are welded onto the stiffeners on the body of the valve (Figure 9). They provide pivot points at which the operating arms are pinned to the valve body.

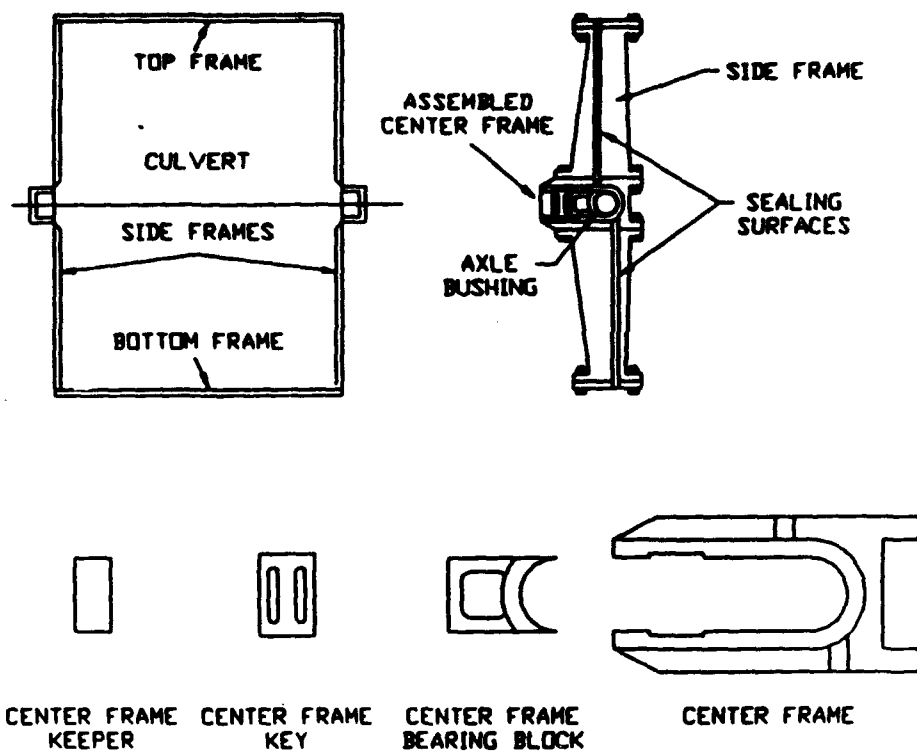
Figure 10. Butterfly valve anchorage assembly

**Axle Bushing:** This is a bronze bushing mounted inside the center frame (Figure 10). It provides a wearing surface for the valve axle and transfers load from the axle to the center frame.

**Valve Frames:** The valve frame is embedded in the walls of the culvert around the perimeter of the valve (Figures 10). It is comprised of several components that provide a pivot point, perimeter sealing surfaces, and a means of removal for repair. Components include the top and bottom frames, side frames, center frame, center frame bearing block, center frame key, and center frame keeper.

**Center Frame Bearing Block:** This slotted bearing block fits in the center frame and provides an upstream bearing surface for the bushing (Figure 10).

**Center Frame Key:** The center frame key is slotted perpendicular to the bearing block and prevents the bearing block from sliding out of the center frame (Figure 10).

**Center Frame Keeper:** The keeper is an end block that holds the center frame assembly together by means of screws spanning through the key and into the bearing block (Figure 10).

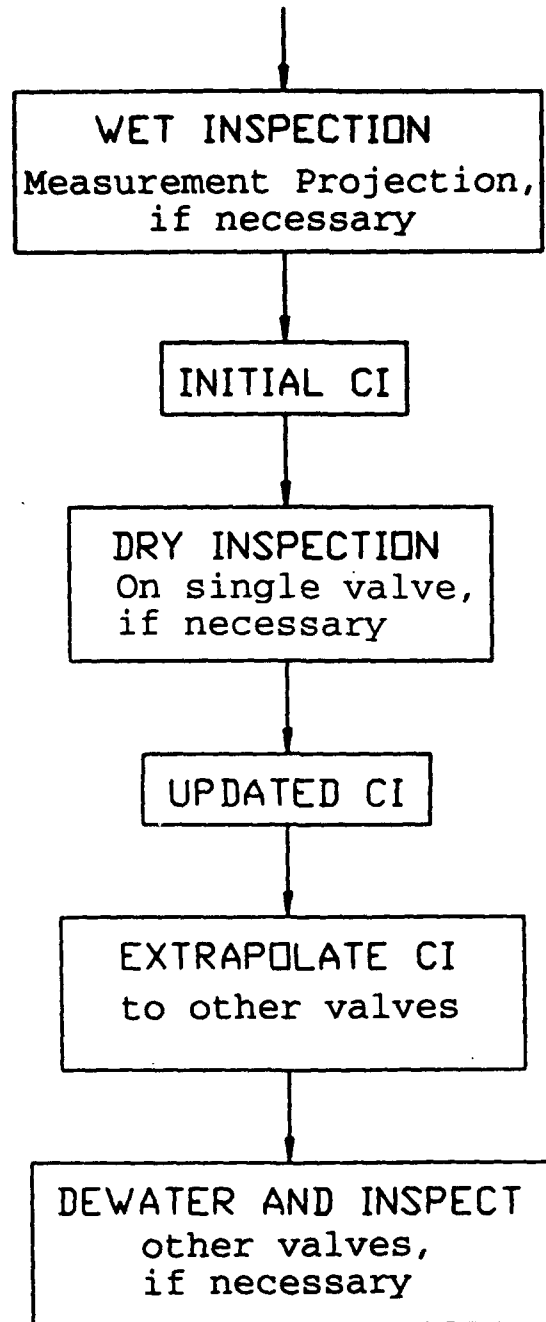
Figure 11. Inspection procedure

28. The overall inspection procedure is illustrated schematically in Figure 11. Many Corps districts currently follow an annual or biannual dive schedule to inspect valves. Working within this established schedule, without dewatering the valve, a wet inspection is the initial procedure in the evaluation process. The information from a wet inspection is used to calculate an initial condition index. If measurement projections are available, they can be used to supplement the diver's inspection. Consecutive wet inspections are performed until the entire lock is dewatered for maintenance or the initial CI value becomes low enough to warrant a further investigation. Wet inspections are intended to minimize the number of routine dry inspections. To get a more accurate condition assessment, a dry inspection could be required to acquire an updated CI. Where appropriate, this updated value can be extrapolated to similar valve structures considering age, type, number of lockages, and water conditions. Other valves with similar conditions may be dewatered.

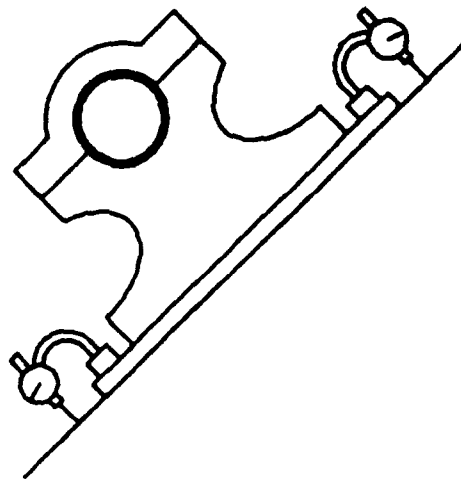
Figure 12. Anchorage movement measurement

**ANCHORAGE ASSEMBLY DETERIORATION:** If anchorage movement becomes significant, it can be detected by visually examining the concrete interface for a line where the corrosive buildup is broken. Indicate the presence of excessively cracked or spalled concrete at the interface around the anchorage connections. Excessive concrete spalling may indicate a displacement occurred at this location at some time and may or may not show up in the current inspection. Small hairline cracks, probably caused by thermal expansion or contraction of the concrete, should be ignored in this analysis. Indicate if the anchor or casting bolts and nuts are significantly corroded. Significant corrosion refers to an approximate 10 percent volume reduction. Indicate if anchor and casting nuts are tightened properly. This is done with a torque wrench or by visual inspection for signs of movement between the bolted components during operation. Indicate if there are any broken or missing anchor or casting bolts and nuts. Measurements of relative movement between the concrete and steel are taken on the top and bottom of each anchorage, with the valve in two positions: (1) open (2) and closed. Measurements are made with a dial gauge attached to the steel and bearing on the adjacent concrete (Figure 12). Displacements should be recorded to 0.001 in.

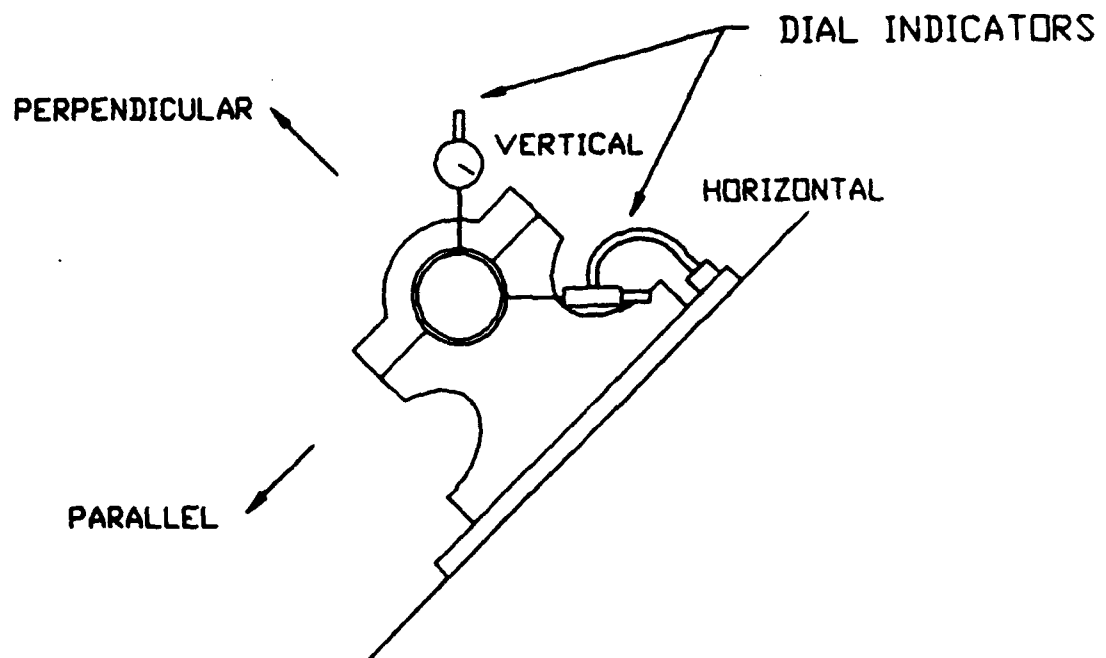
Figure 13. Trunnion assembly wear measurement

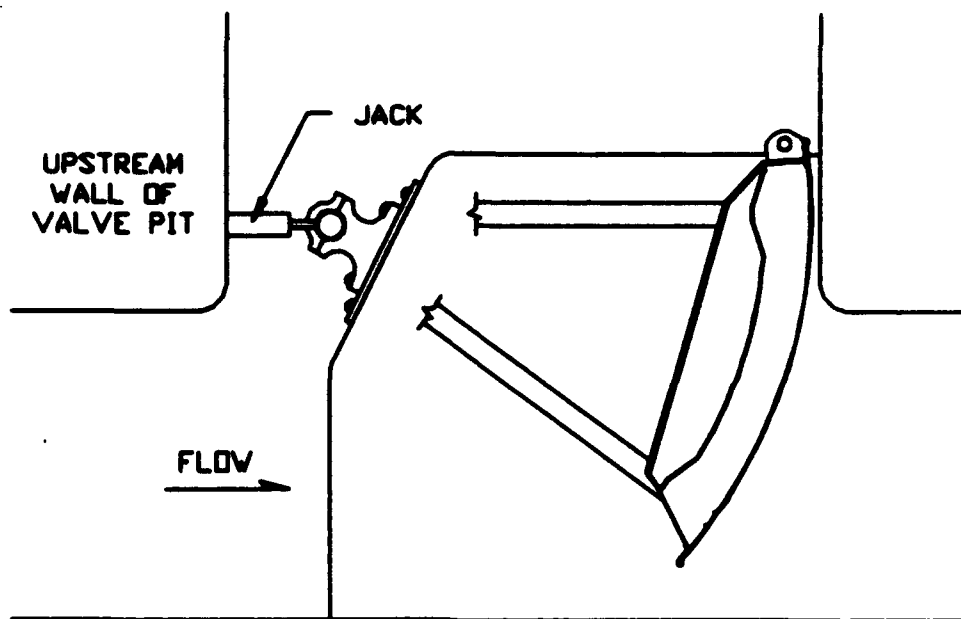
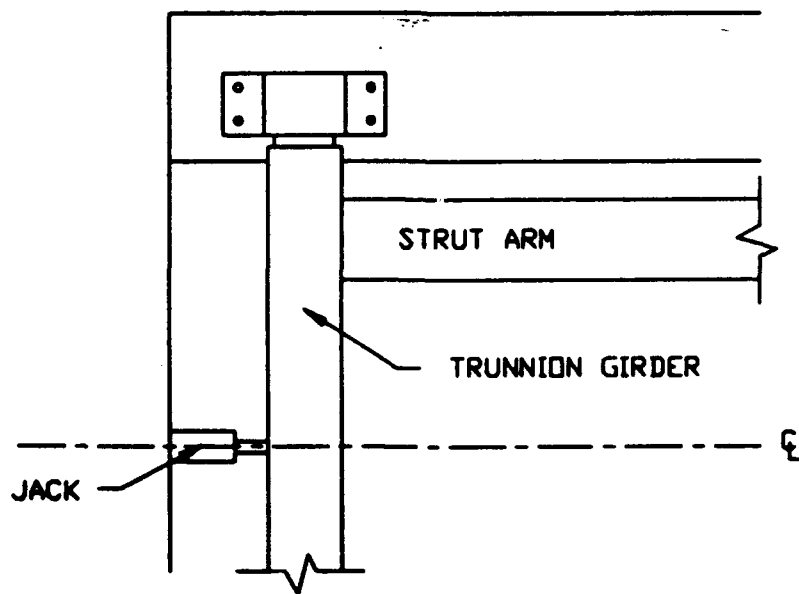
Figure 14. Trunnion assembly jacking locations

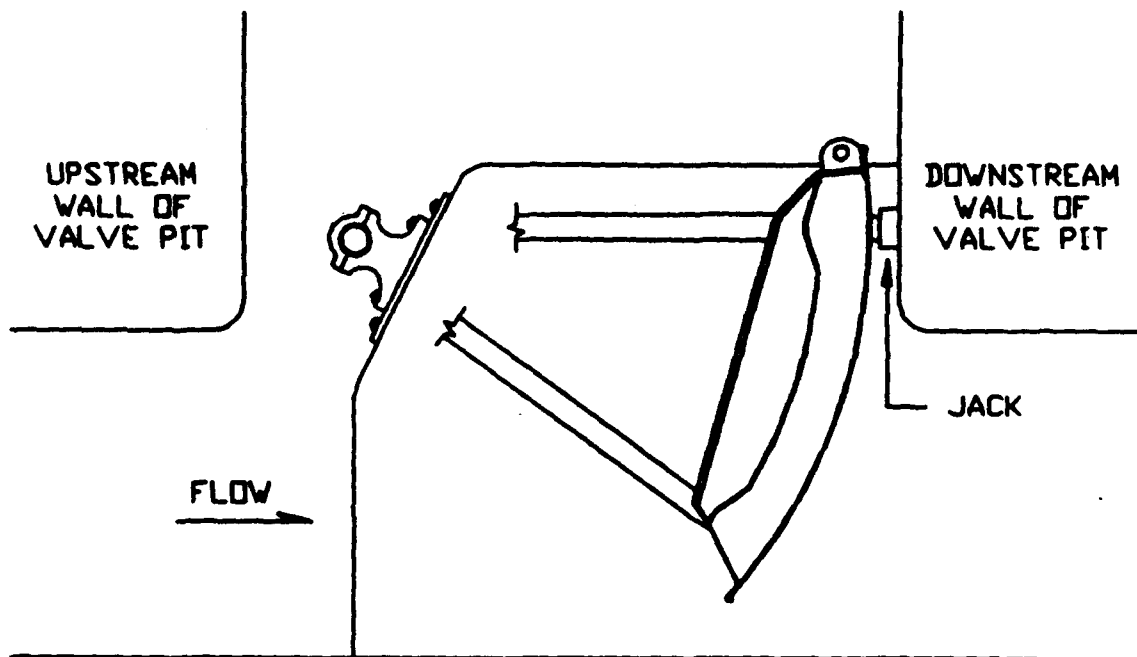
Figure 15. Skin plate jacking location

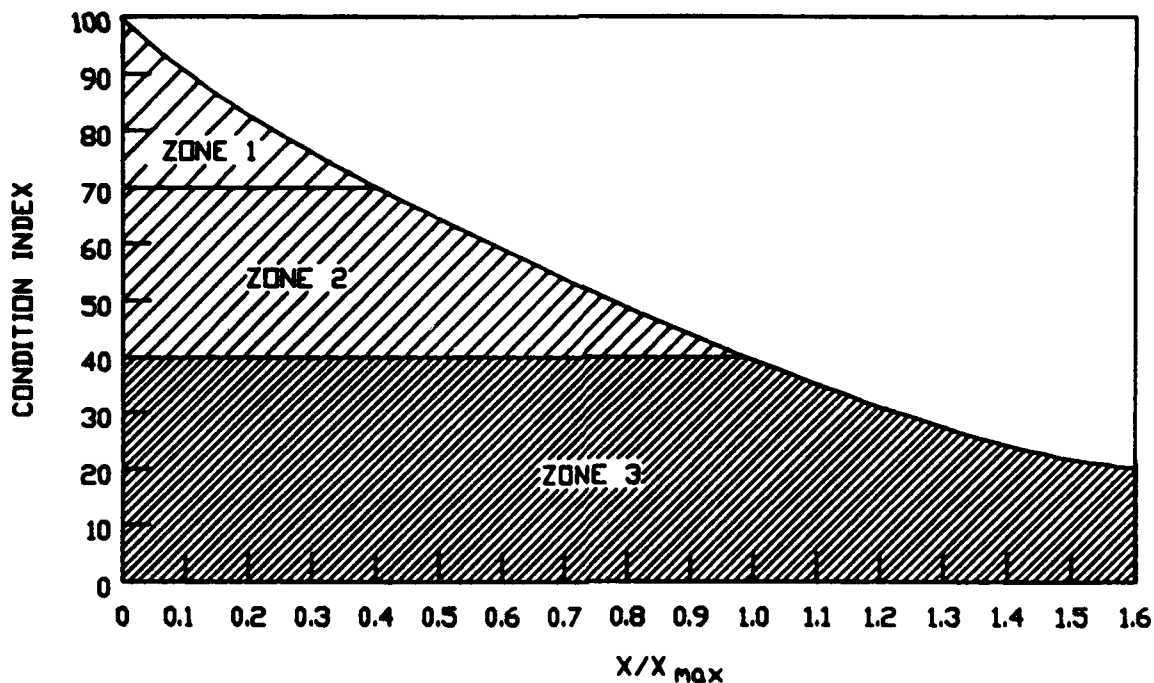
Figure 16. Condition index related to  $X/X_{max}$

where  $X_{\max}$  is some limiting value of  $X$  (Greimann and Stecker, 1989). The previous description of condition index zones (Table 1) defines  $X_{\max}$  as the point at which the condition index is 40; that is, the dividing point between Zones 2 and 3. Figure 16 illustrates the equation and zones from Table 1. Experts have selected  $X_{\max}$  to be the point at which the valve requires immediate repair or, at least, a more detailed inspection than that described herein.

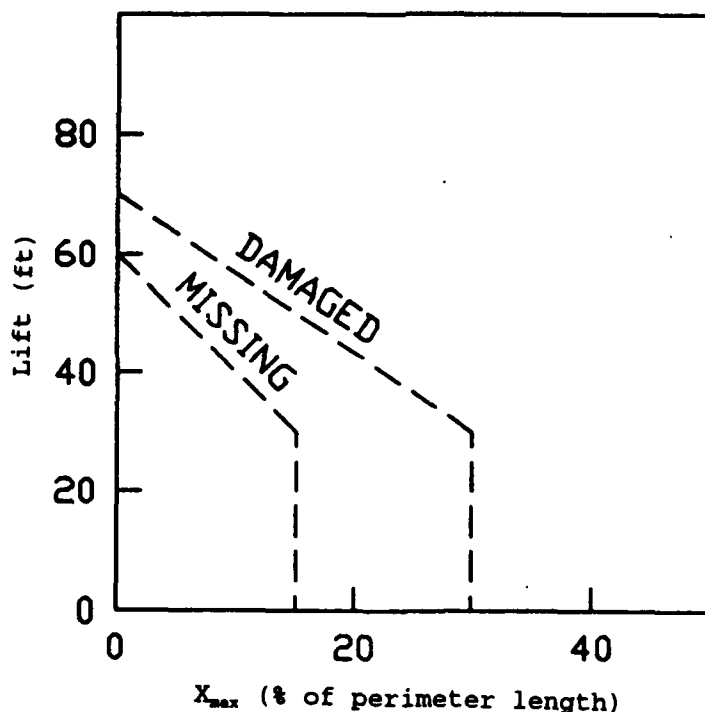
Figure 17.  $X_{max}$  for seal condition distress

The condition index for all heads will not be less than 30. The CI describing the seal condition is the minimum of the damaged and missing seal CIs.

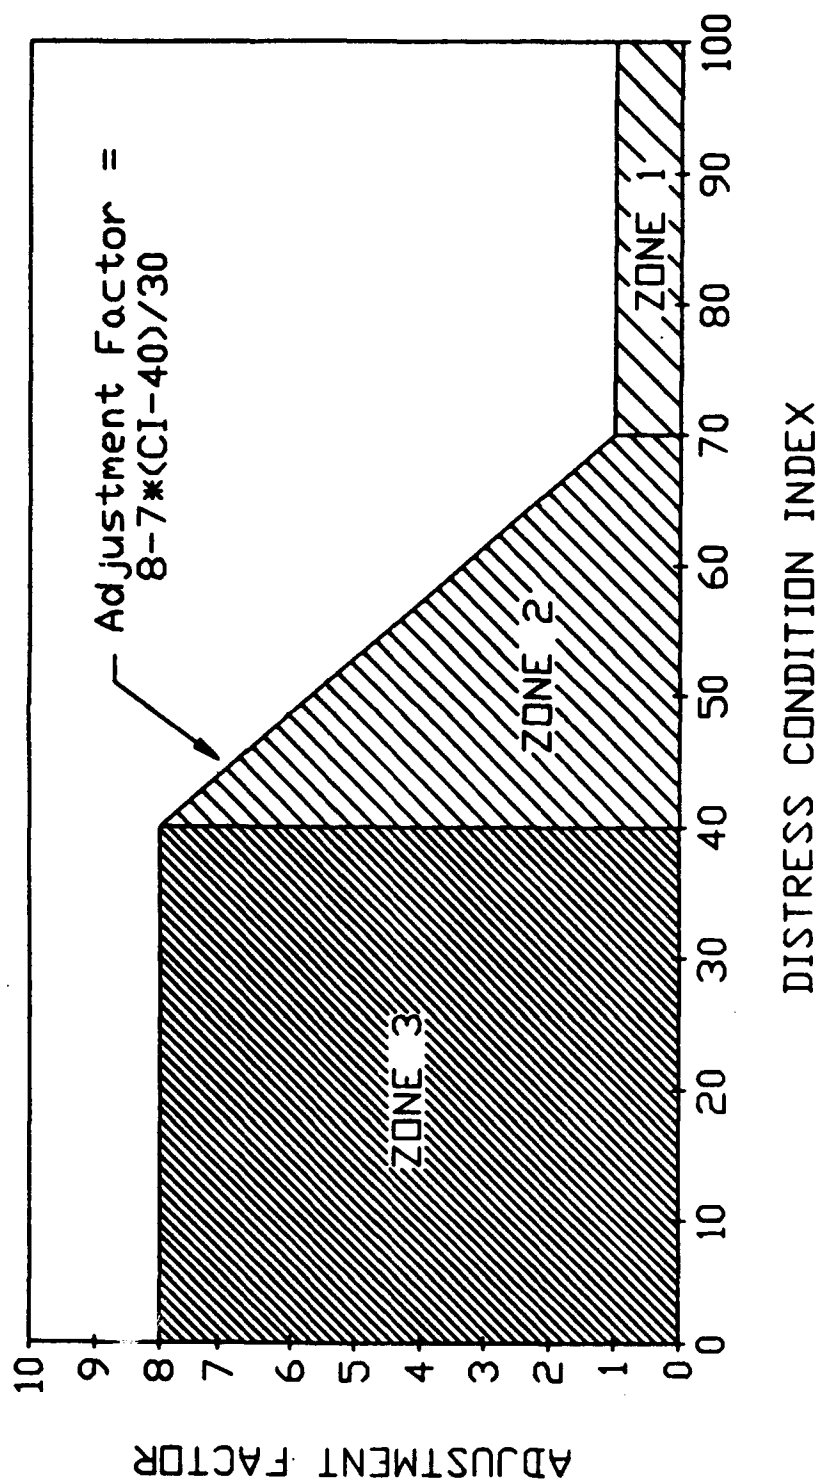
Figure 18. Weight adjustment factor for condition index

88. Based on similar work done by the ISU project team (Greimann and Stecker, 1989), the concept was established that, as a distress became more severe, its relative importance became larger. To account for this, a variable adjustment factor was introduced to increase the distress weighting factor  $w_i$  as its CI approached Zone 3. The adjustment factor plotted in Figure 18 has a maximum value of eight; that is, if a distress has a CI less than 40, its importance increases eight times.

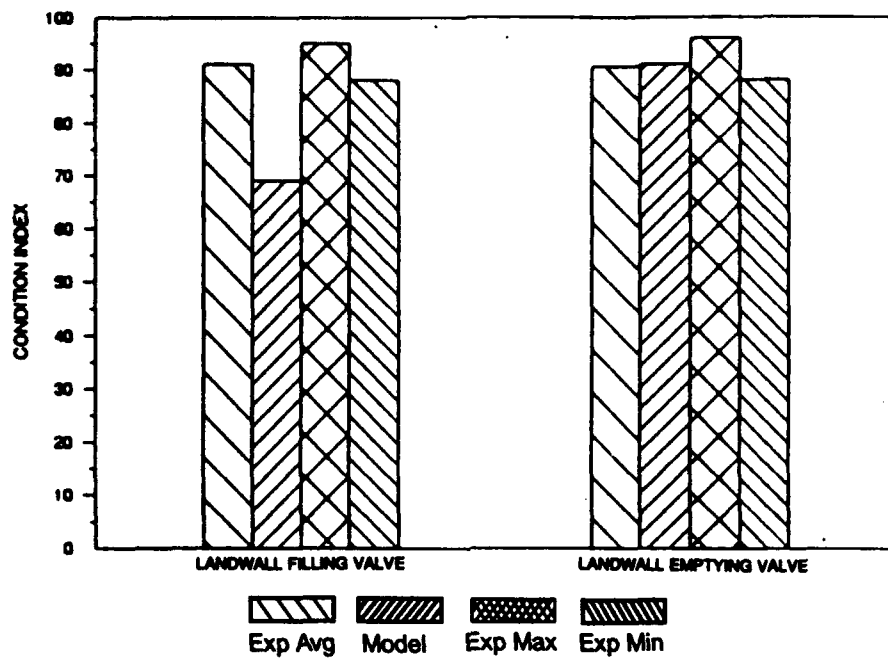
Figure 19. Anchorage assembly deterioration

#### Anchorage Assembly Deterioration (Figure 19)

94. The calculated anchorage assembly CI for the emptying valve closely approximated the expert average. The calculated CI for the filling valve was 22 points lower than the expert average. After the experts had expressed their subjective ratings, a lengthy discussion concerning the significance of anchorage movement resulted in lowering the  $X_{max}$  value to 0.005 in. In other words, the experts judged that almost any measurable movement of the anchorage is a concern. After this discussion and modification, the experts did not

return to modify their subjective evaluations to reflect their reduced  $X_{max}$ . Therefore, the calculated CI was lower than the expert average.

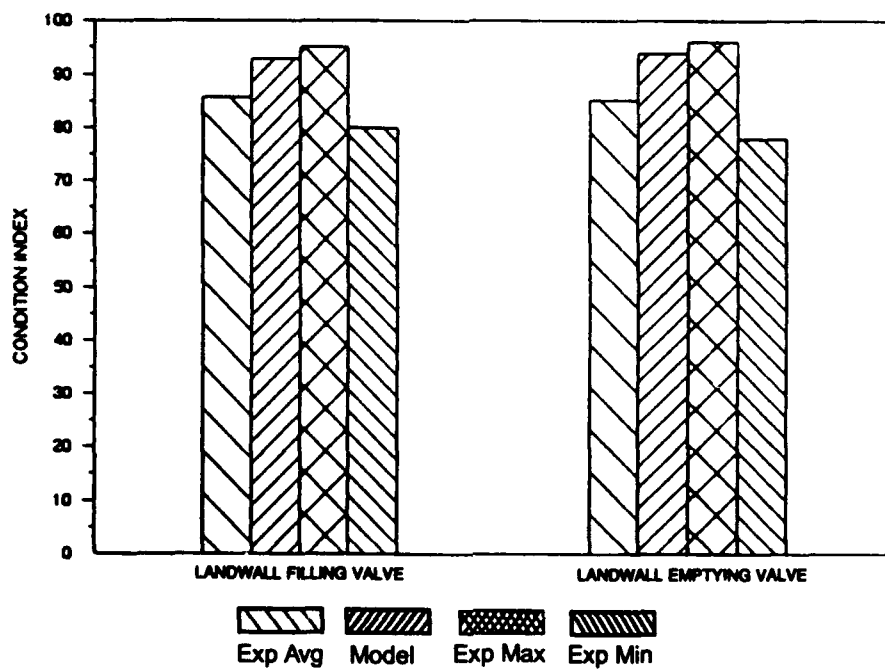
Figure 20. Trunnion assembly wear

Trunnion Assembly Wear (Figure 20)

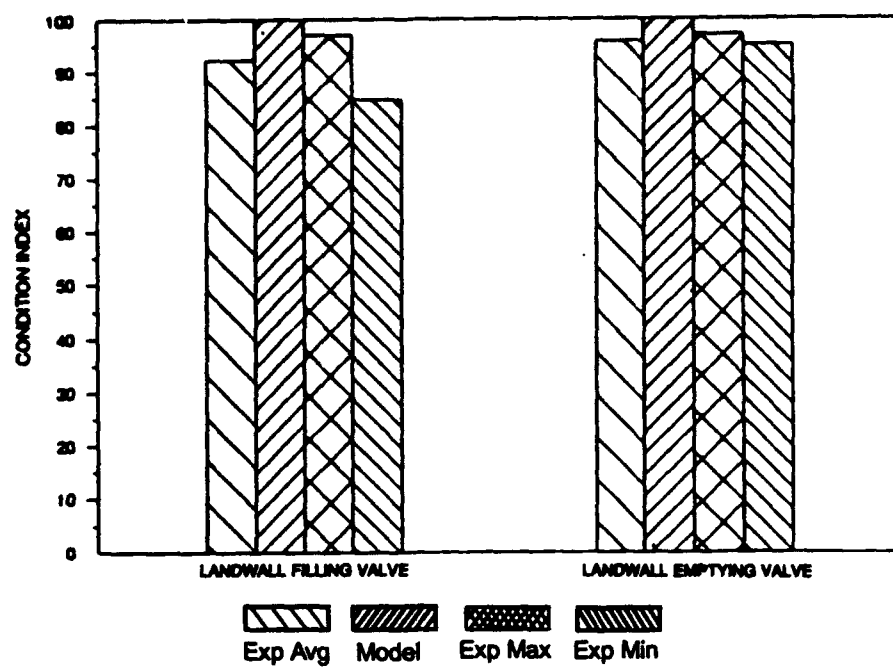
Figure 21. Seal condition

Seal Condition (Figure 21)

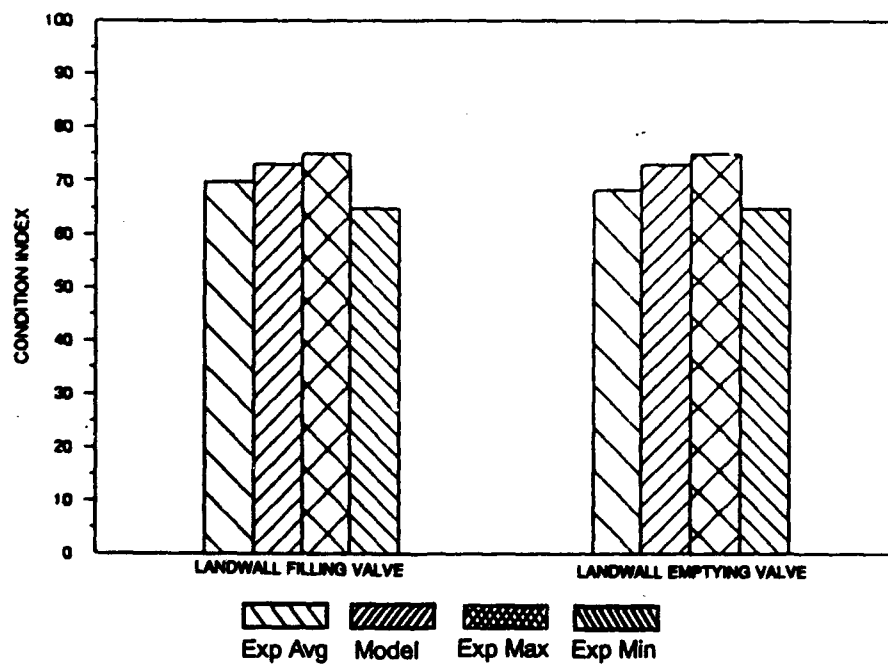
Figure 22. Corrosion

Corrosion (Figure 22)

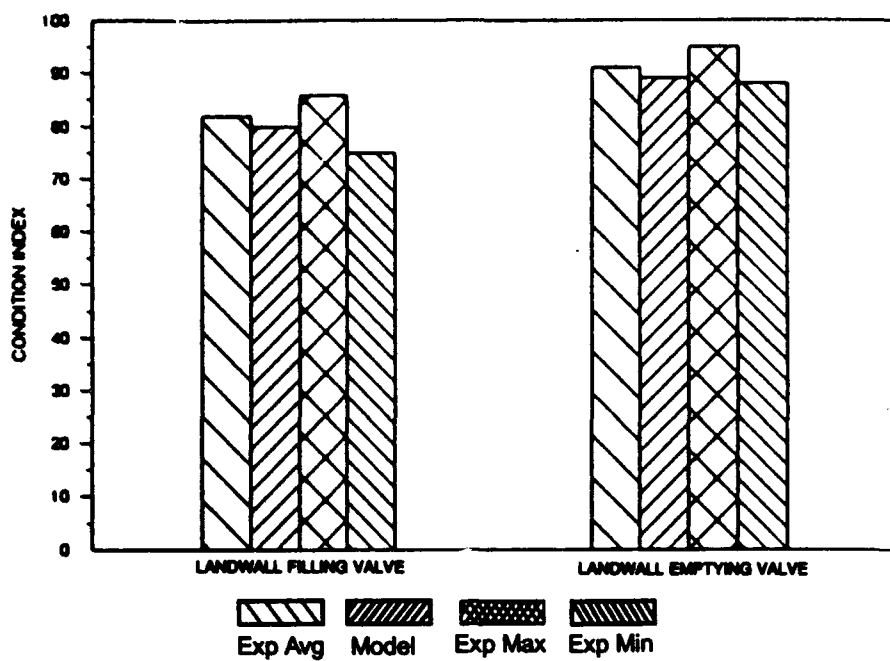
Figure 23. Lifting bracket bushing wear

Lifting Bracket Bushing Wear (Figure 23)

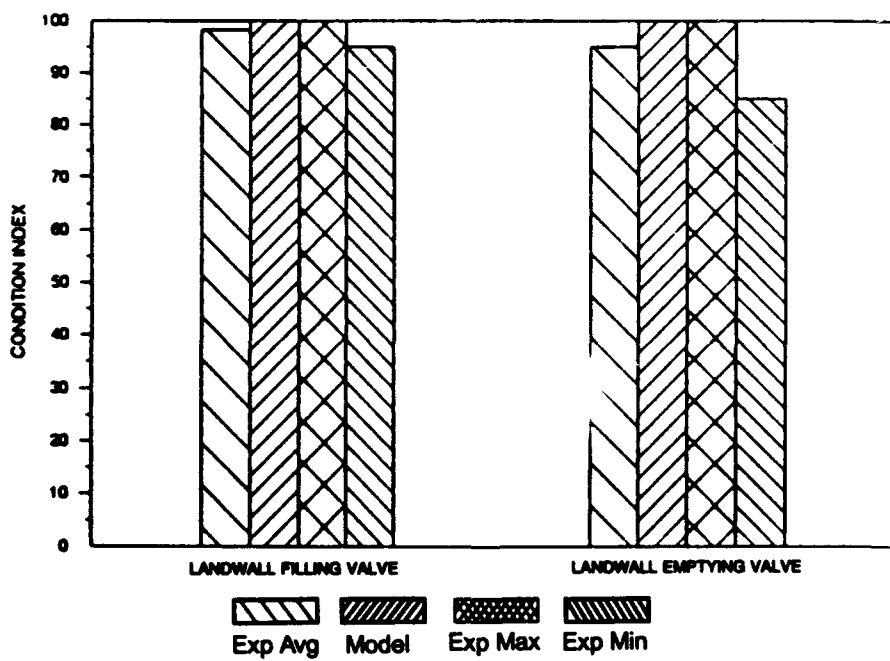
Figure 24. Cracking

Cracking (Figure 24)

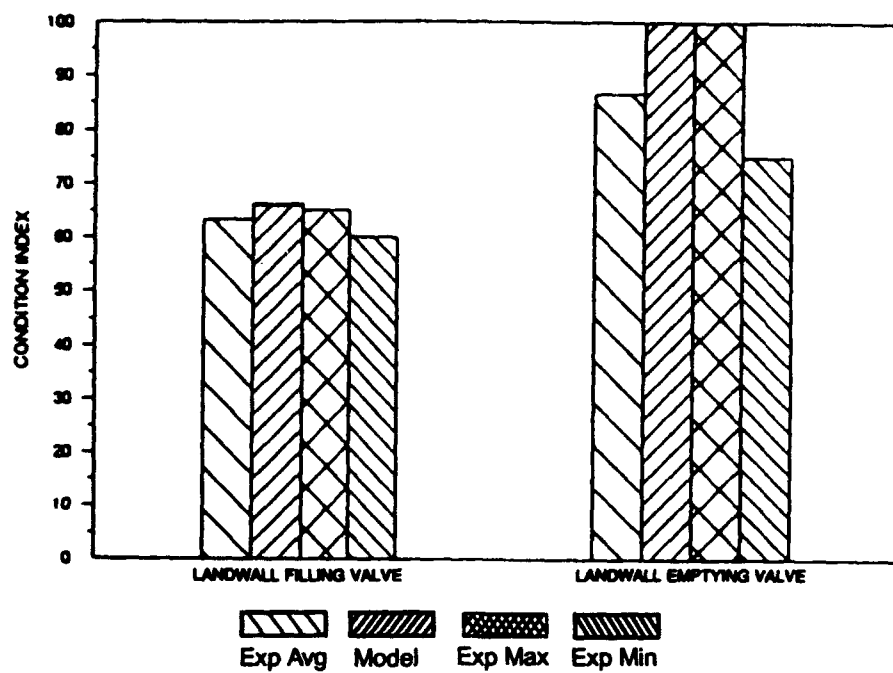
Figure 25. Cavitation/erosion/abrasion

93. The following bar charts (Figures 19 through 25) present the experts' subjective condition index versus the CI calculated by the rules discussed earlier for the seven distresses associated with a dry tainter inspection. One graph is presented for each distress. Within each group of data are four columns of data that represent

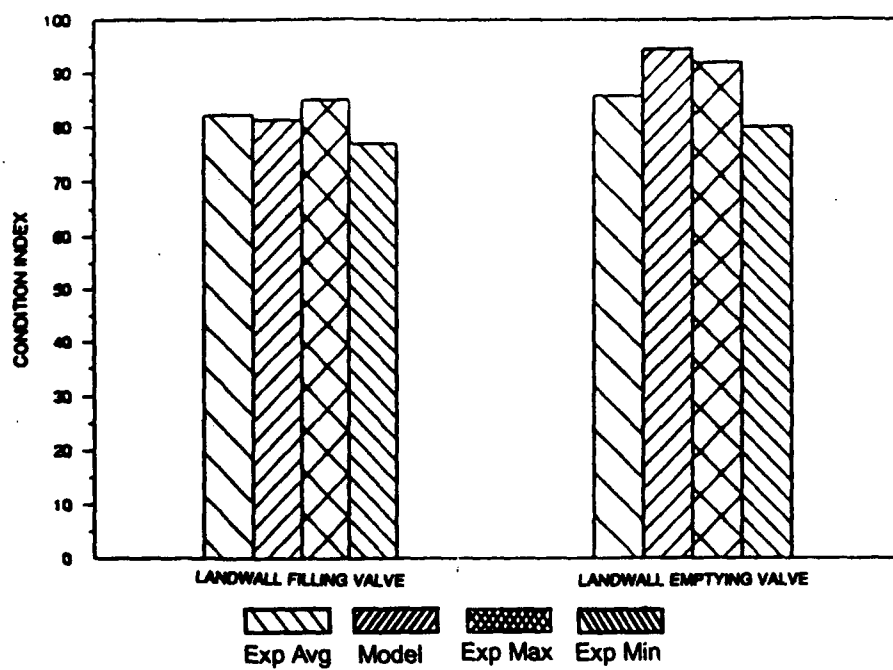
Figure 26. Overall ratings for the valves

The results of a comparison between the expert rating and the calculated values for each distress are summarized in the following paragraphs. Figure 26 shows a comparison for the overall index of the valve.

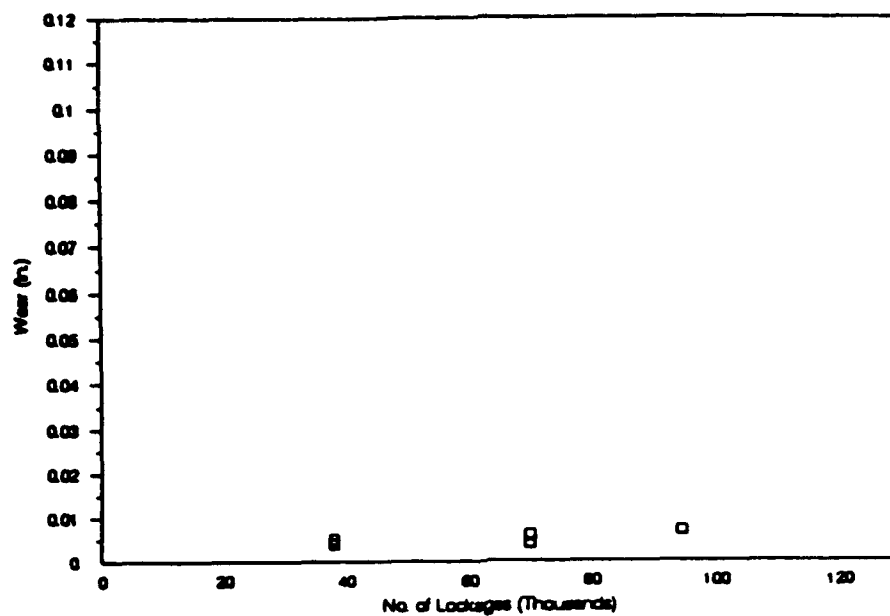
Figure A1. Tainter valve pin wear

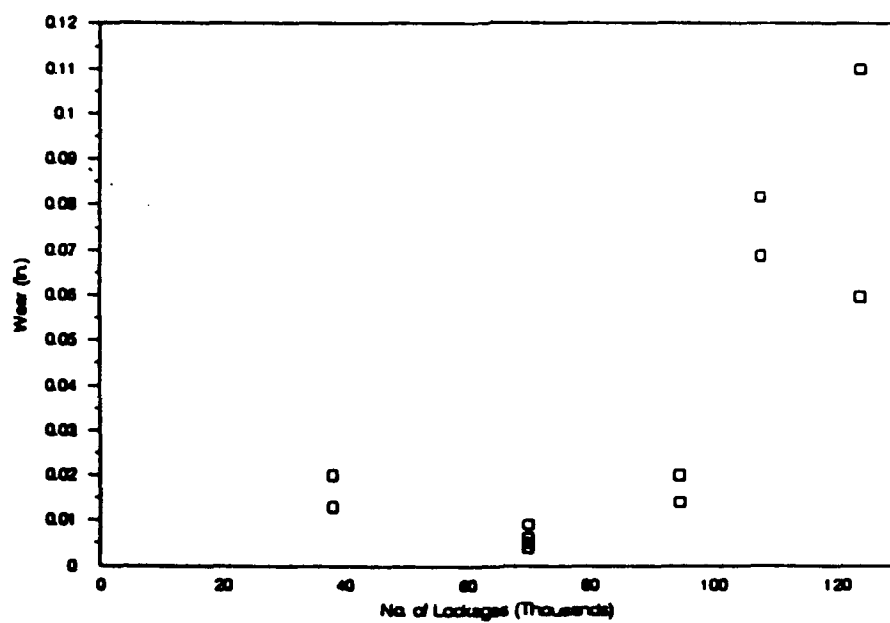
Figure A2. Tainter valve bushing wear

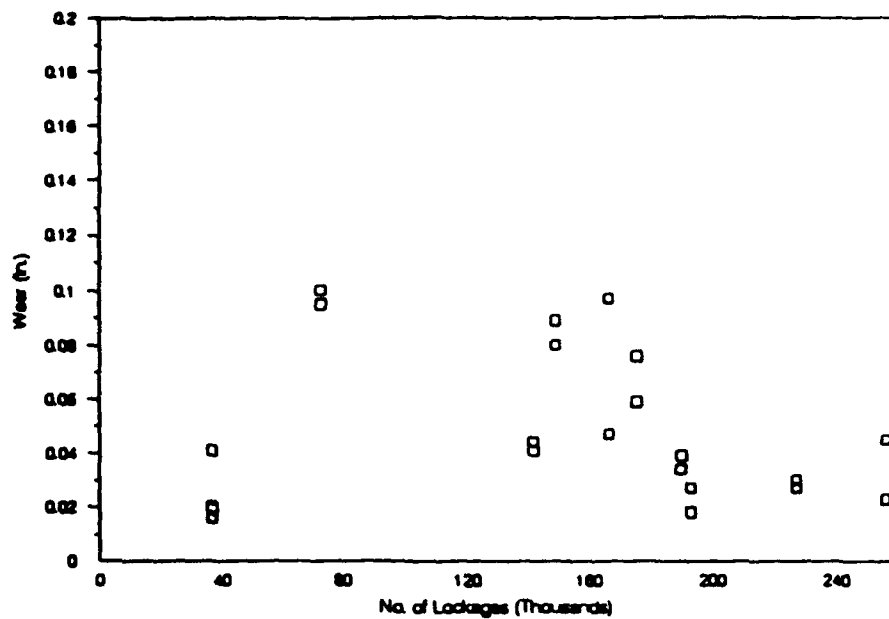
Figure A3. Butterfly valve axle wear

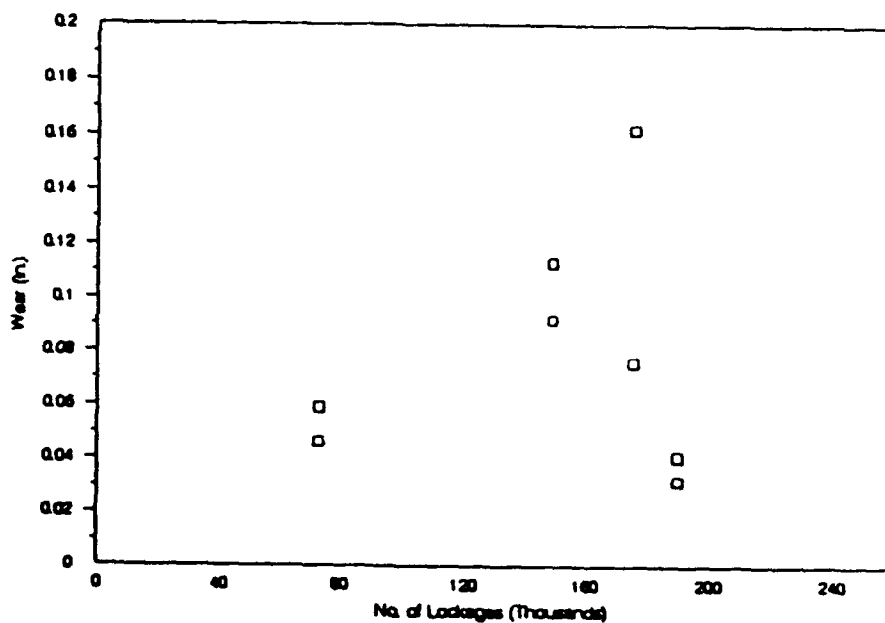
Figure A4. Butterfly valve bushing wear
